Rio de las Vacas

Stream and Riparian Restoration Plan and Recommendations

**Santa Fe National Forest
Forest Service, Region 3**

**Gary Asbridge
Fish Biologist
Mt. Hood National Forest
Forest Service, Region 6**

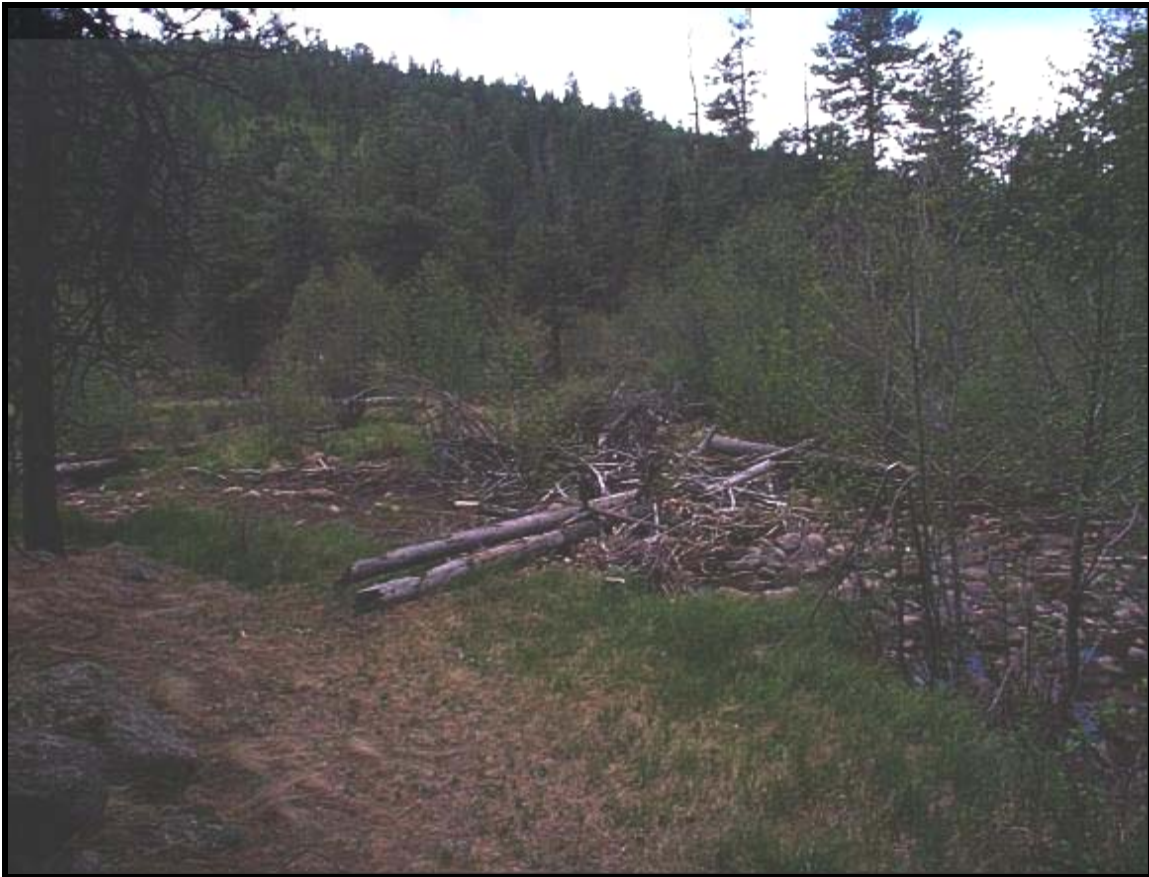
Reach 8 was a short meadow reach (< 0.5 miles in length) that had multiple channels due in part to a logjam in the lower section of Reach 9 that has caused a channel avulsion (Figure 1). It appears the channel has incised in several areas and the width to depth ratios are likely higher than in the past. There is a stand of timber to the south of the main channel that likely provided LWD to the channel and flood prone area historically (there were cut stumps in this stand) and LWD was also transported downstream from Reach 9 (as evidenced by the logjam mentioned above). The substrate is relatively large, cobble and small boulder, with low amounts of smaller gravel that provide suitable spawning habitat for cutthroat trout. More than likely the smaller gravel is transported through the reach during higher flows as there is limited roughness. It is the opinion of the author that this entire reach was likely a wet meadow complex prior to the channel incision and increased width to depth ratio caused by the removal of natural roughness elements.

Figure 1. A natural logjam located approximately 200 feet upstream from the Clear Creek/ Rio de las Vacas confluence. The logjam has caused a channel avulsion (left side of photograph) that has created a side channel that likely provides excellent habitat when water flows through it.³

There is an excellent opportunity here to re-establish the wetland complex by placing several well placed logjams in the main channel and also placing wood in the flood prone areas (low spots). The logjams would cause the channel to aggrade and allow for more frequent flood prone area inundation, as well as re-water or create new side channel habitat. This wood placement in and outside the channel would also facilitate deposition of finer substrates that would increase the retention of spawning sized gravel as well as sand and silt that would improve conditions for riparian vegetation establishment. The author believes this reach provides the best opportunity to create excellent salmonid habitat in a relatively short period of time (< 5 years depending on precipitation and stream flows) of all the reaches proposed for restoration.

Logjams in the channel should be placed in areas where channel aggradation would result in inundation of nearby flood prone areas. Valley wall to valley wall cross sections would help identify the true low spots where flood prone area wood should be placed and also help determine final logjam locations. The cross sections, coupled with return interval flow estimates, could also be used to predict the area of inundation at different flows.

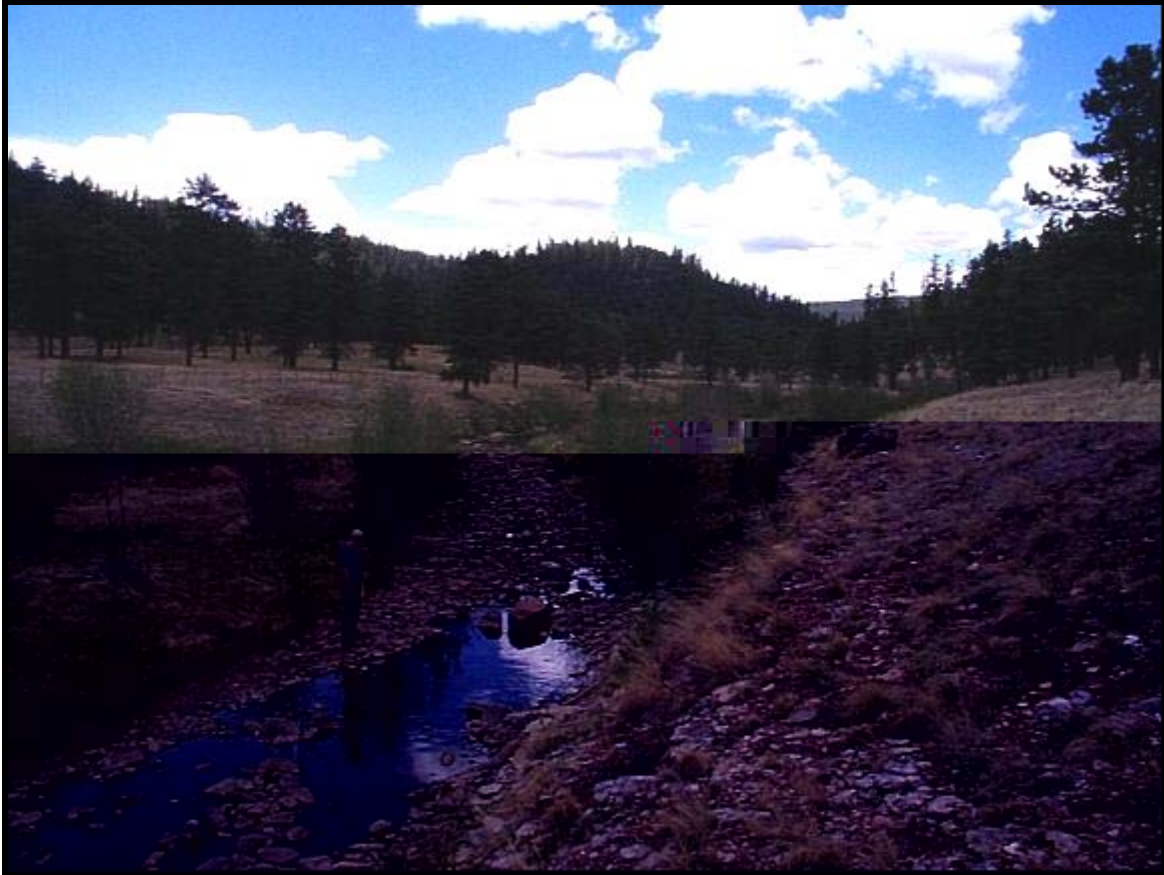
habitat, larger substrates, and very little woody riparian vegetation. It is unlikely this reach naturally had large amounts of LWD in the channel and flood prone area historically but the author believes LWD was likely present (more than now certainly), either routed from upstream reaches or from the occasional conifers or cottonwoods falling into or near the channel. In some areas in Reach 6 the channel was actually quite close to forested hill slopes and it is quite probable that trees fell into or along the channel with some regularity. Pines were also relatively abundant on the old terrace (Figure 3).

Figure 3. A representative photograph of Reach 6 that illustrates the relative channel confinement between old terraces. Woody riparian vegetation (willow and alder) is generally lacking although some areas are starting to recover. Note the larger substrate and wide, shallow channel that is indicative of much of Rio de las Vacas.

Restoration efforts in this reach should focus on reducing the width to depth ratio and promoting woody riparian vegetation growth. Wherever possible, the stream and associated flood prone area should be fenced to prevent cattle access. Areas both within and outside fenced exclosures could be planted with willow, alder or cottonwood to speed vegetation recovery. Over time, the encroachment of riparian vegetation will result in a narrower, deeper stream channel. However, this will take years (likely 10 or more) and will depend largely on adequate moisture, stream flows and keeping livestock out of the stream and riparian area. Proper construction and maintenance of fences must be a priority. The existing exclosure should be maintained prior to any new fence construction.

There is also an opportunity here to speed recovery by placing wood and/or boulders along stream margins. These “margin jams” would act to concentrate flow in a smaller area plus promote deposition of substrate behind the jam downstream. This bar development would in turn be an excellent place for vegetation establishment and the end result would be a narrower, deeper channel with more riparian vegetation. Spawning sized gravel would also tend to collect and be sorted downstream of the margin jams. Note that in the wider, flatter areas some flood prone area wood placement would be advisable in the event channel avulsion occurs. However, margin jams, as opposed to channel spanning jams as recommended in Reach 8, would be much less likely to completely dam the stream and result in channel avulsions. Margin jams should not encroach into the bankfull channel more than 1/3 of the total width.

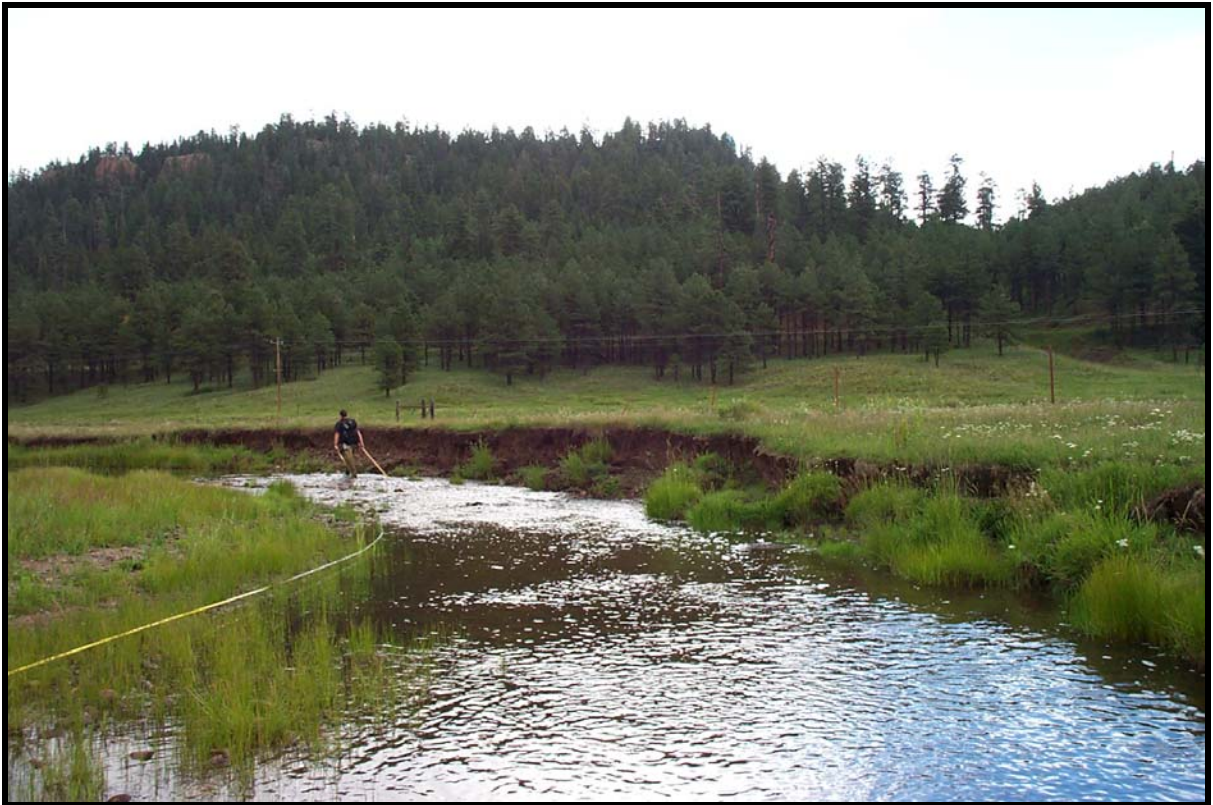
There were several sections of vertical stream bank in this reach that was actively eroding (Figure 5). Other sections had sloughing banks that could lead to vertical stream banks if

cattle are allowed to continue grazing in the riparian area and/or the banks aren't stabilized by vegetation. Pulling these vertical banks back

Figure 5. Actively sloughing and vertical stream banks in Reach 4 of Rio de las Vacas not only contribute fine sediment to the stream channel but also retard woody riparian vegetation establishment. (Photo taken 8 Aug 2001)

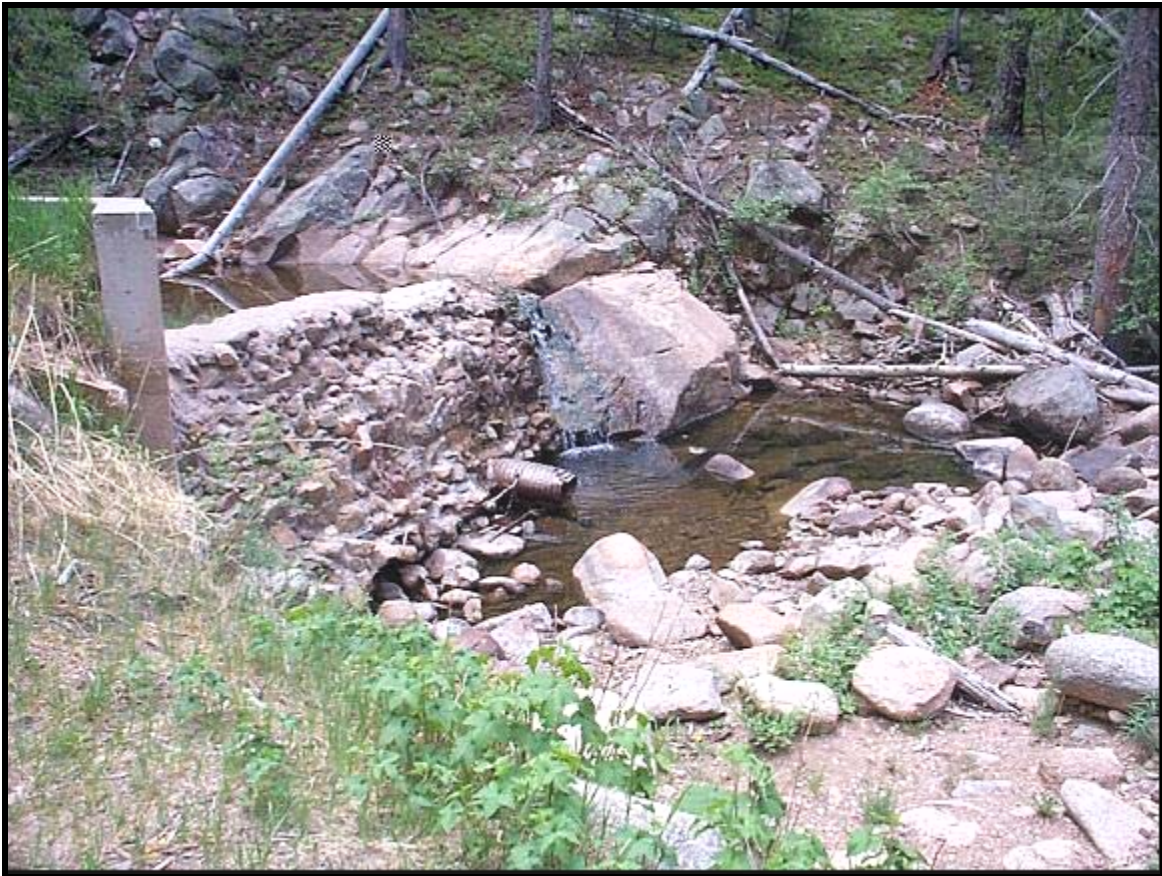
Figure 10. A barrier built around 1980 in Rio de las Vacas designed to prevent non-native salmonids from migrating upstream.

Raise the entire barrier 6" or so. At present the east side is the weak point.

Remove the boulder pool control downstream and place the boulders in the pool to fill in the pool; the bigger the boulders the better.

Widen the channel downstream of the barrier by removing the boulder "bar" on the west side. This will make the stream wider and shallower resulting in less likelihood of a pool forming.

- Shore up the west bank below the barrier, where it looks as if high flows have eroded the bank, by placing the rock removed from the bar (see foreground, Figure 10).
